**ISSUE:**

**GUTTER CLAMP SPACER KIT**

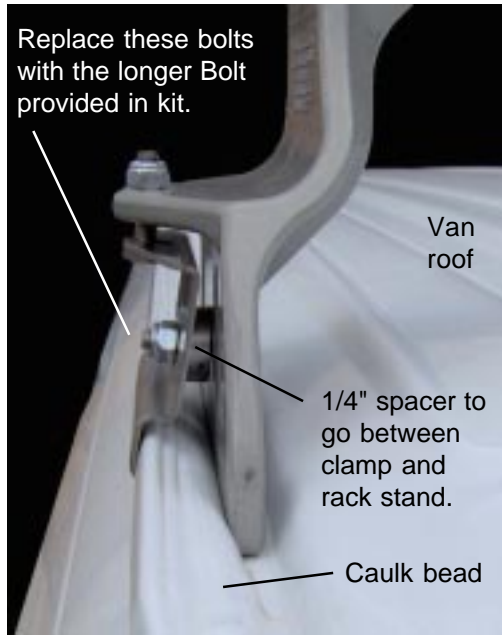
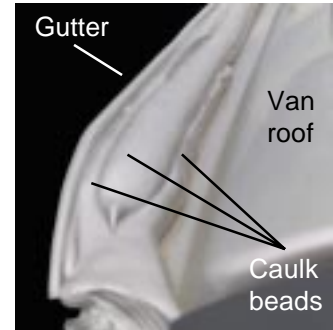
Some 2005 model year Chevy and GMC full size vans have been produced with large amounts of caulking in their roof gutters. This situation occurs when the bolts supplied, with the model numbers listed to the right, are too short as the caulk gap between the stand and mounting bracket increases. Both the new "Universal Clamp" and the "GM" style clamps are affected.

<b>Mounting Kit #32-0134</b>	
<b>Used on Models:</b>	
<b>234-3, 236-3, 233-3, 209-3, 219-3, 229-3, 2095-3, 2097-3, 210-3</b>	
Quantity	Description
4 ea.	5/16-18 x 1-1/4" Carr. Bolt
4 ea.	1/4" Spacer

<b>Mounting Kit #32-0135</b>	
<b>Used on Models:</b>	
<b>211, 213, 2136</b>	
Quantity	Description
2 ea.	5/16-18 x 1-1/2" Hex. Hd. Bolt
2 ea.	1/4" Spacer

Using the longer bolts supplied in this kit, place the round 1/4" thick spacers between the gutter clamp and the ladder rack base. This will compensate for the thickness of the caulking in the gutter. In extreme cases, a portion of the caulk might have to be cut out of the gutter and then re-caulked after the rack is installed.
